Historic Preservation Covenant Review Sheet – 2025

Burnt Coat Harbor Light Station
 Owner: Town of Swan's Island

Historic Preservation Covenant Review Sheet - 2025
Swan's Island Lighthouse - Burntcoat Harbor Lighthouse

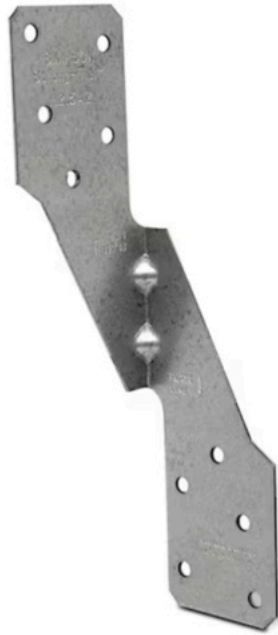
Simpson Strong-Tie
3 in. x 3 in. x 1-1/2 in. Galvanized Angle

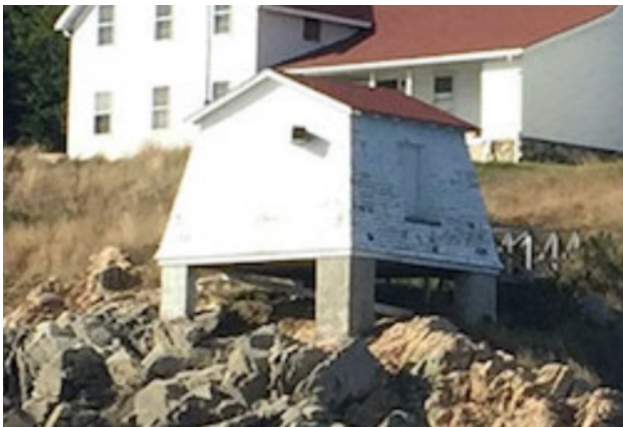
This is the Bell House from the South East Side. The Lichen is apparent on both the south and east sides of the building.

This project is to strip and paint the Bell House and then reroof it without stripping the old shingles. As the Bell House is on the rocks, this project would be facilitated by simple OSHA compliant pump-jack scaffolding.

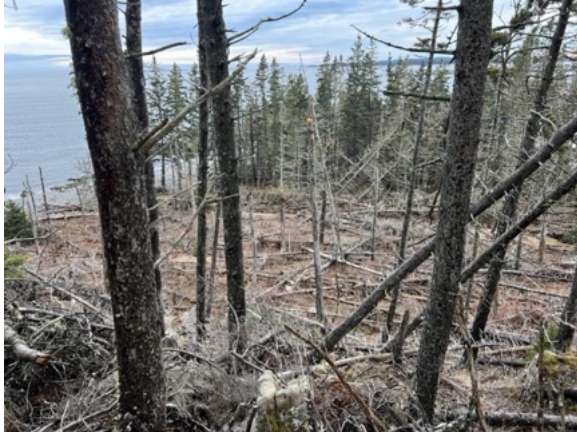
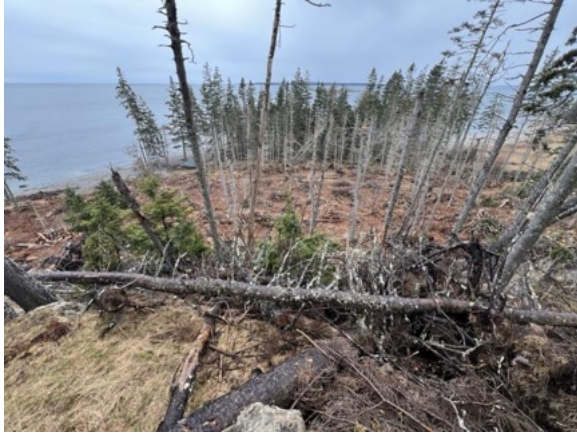
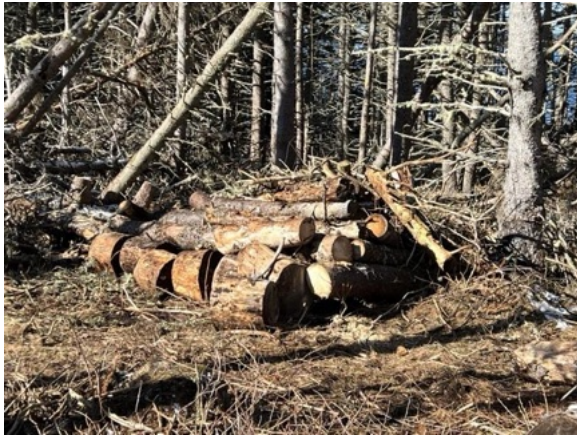
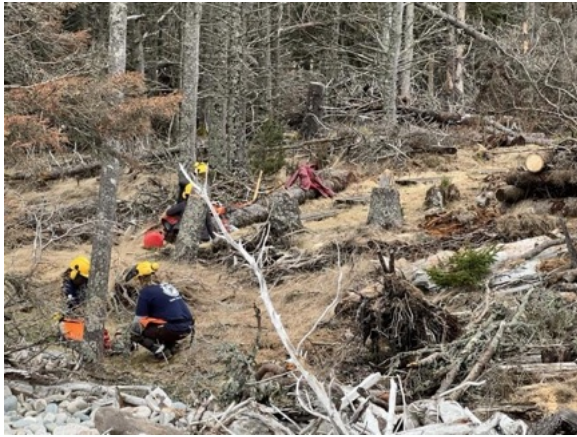
The first and probably largest of the projects was clearing the extensive blow-down area on the Long Point Beach Trail. This was also the portion of the program that would sharpen their chainsaw skills for the summer season to come. For nearly the first four days of the "training hitch" most of the 12-person crew, broken up into smaller sub-groups, tackled the massive task of cleaning up the wide field of blown down trees. The strategy employed in this clean-up and renewal was to cut all fallen or blown-over trees into smaller logs and branches for incorporation into "habitat piles." Habitat piles are ideal for such situations, since they provide a great alternative environment and cover from predators for the many small mammals and birds that may have been displaced as a result of the original blow-down. For those interested in a short description of habitat piles and their advantages, please visit the U.S. Fish and Wildlife Service article at <https://www.fws.gov/story/2023-05/brush-piles-safe-space-wildlife>. We are certain that when you visit the beloved Long Point Beach Trail, you will enjoy first-hand how much "cleaner" the area appears, and we're looking forward to what type of flora will begin to grow in the field. Until then, please see a few before and after photos below to get a sense of the scope of the large project and the truly remarkable transformation that the MCC team made to the Long Point Beach Trail.

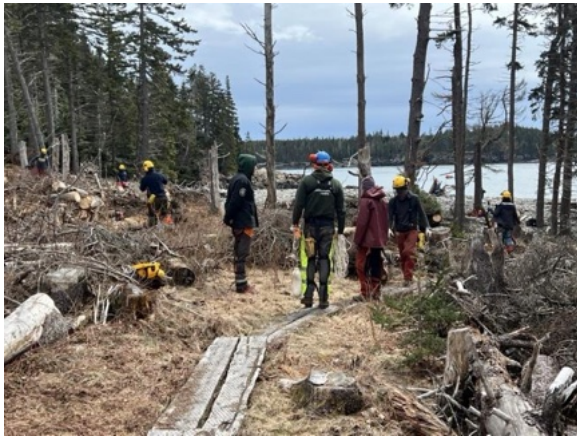
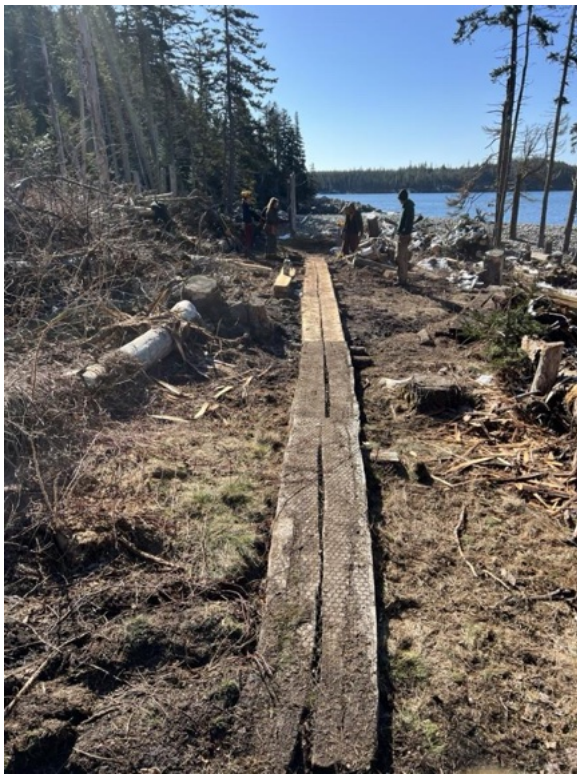
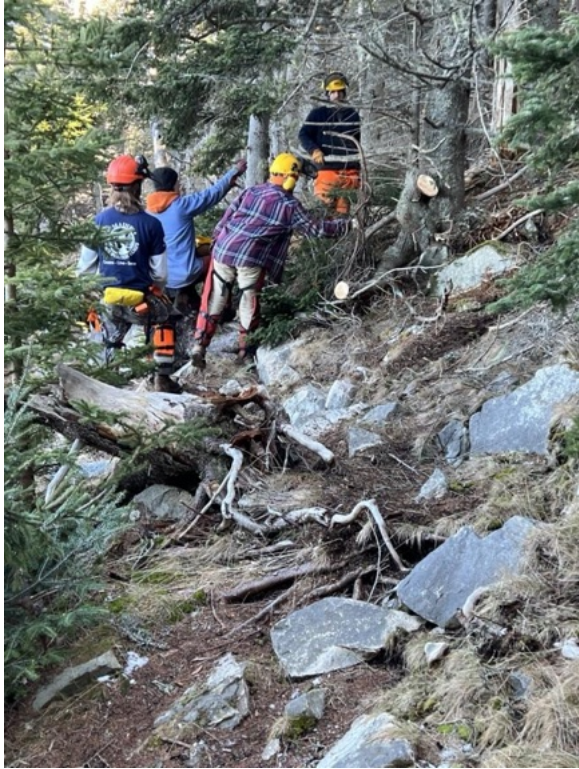
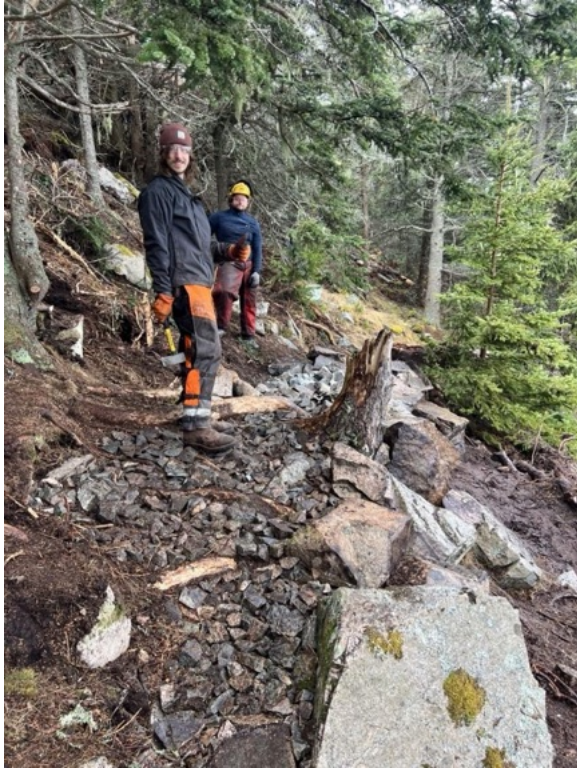
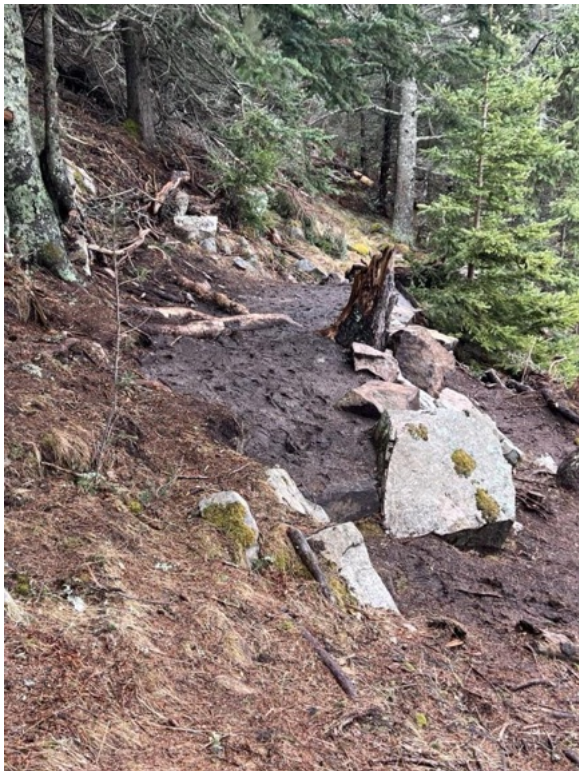
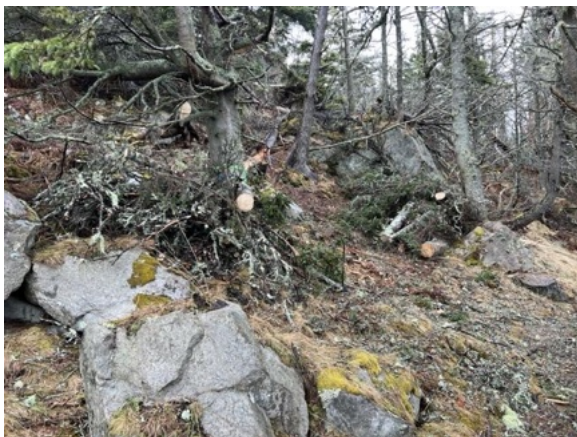
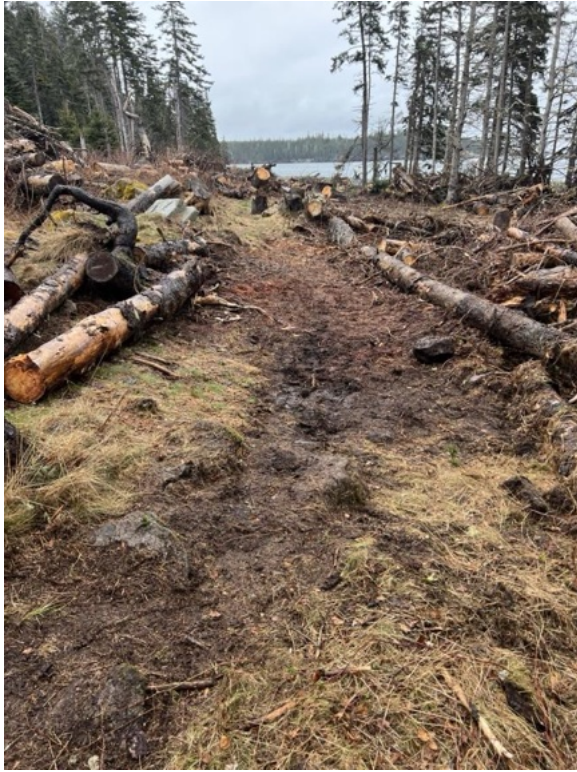
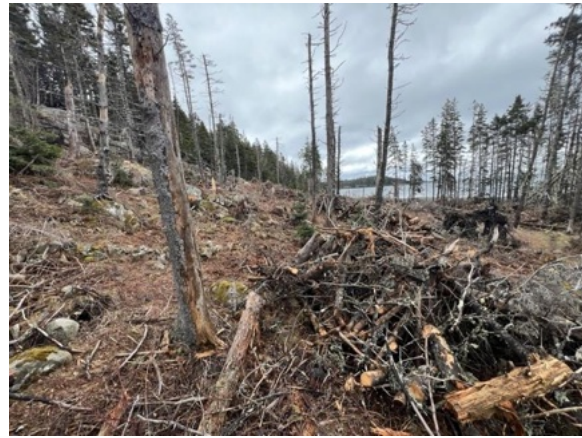
Several additional substantial projects were completed along the Long Point Beach Trail, including: bog bridge replacement, trail section replacement, trail clearing, and a small trail re-direct.

Upon closer inspection, it was realized that almost all of the current bog bridge materials would be unsuitable for re-use. It was also decided that a straighter, safer, and potentially drier direction should be undertaken for the new bog bridge. While we didn't have enough bog bridge timber to extend the bog bridge to the beach stones, the re-direct and new bridge is straight, with excellent footing, and even employs a large stone culminating the beach-side end of the bridge. We expect that next year we will incorporate the necessary bog bridge extension into the work program.

A sub-team of the MCC group also tackled renovating one portion of the trail relatively close to the blow-down area, which is particularly close to the edge of the seaside drop-off. This section required manually cracking large pieces of granite into small pieces to create an interlocking layer of stone underneath a new top layer of mineral-soil (high in inorganic

The same sub-team that had tackled the rocky renovation above also cleared a fair portion of the Long Point Beach Trail near the base of the upward climb toward the summit stairs. Evidence of this clearing operation can be seen in a couple new habitat piles.

And finally, the same sub-team that completed the bog bridge work also cleared a new re-direct for a small portion of the trail near the bog bridge, where it was decided that a straighter trail would greatly benefit our visitors, eliminating several rather hazardous twists and turns. We also expect to add a bog bridge to this segment next year.

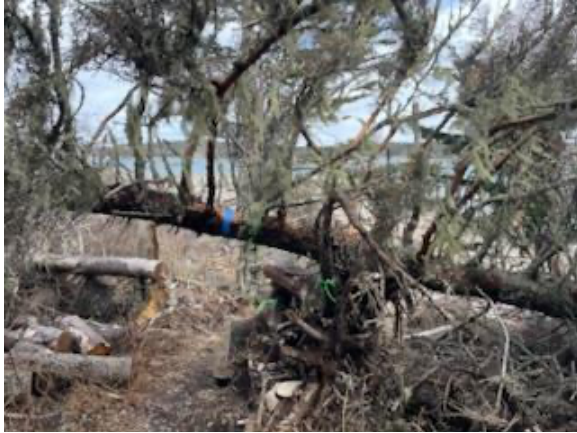
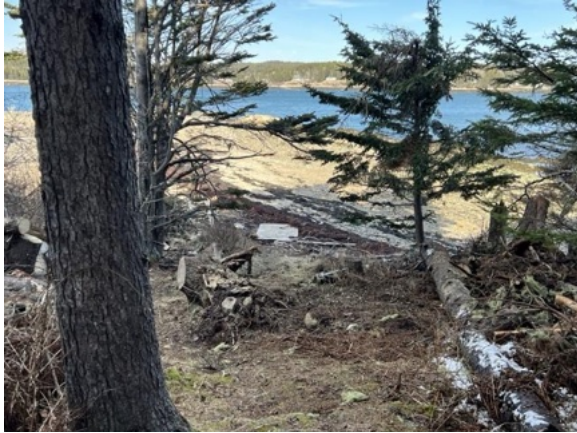
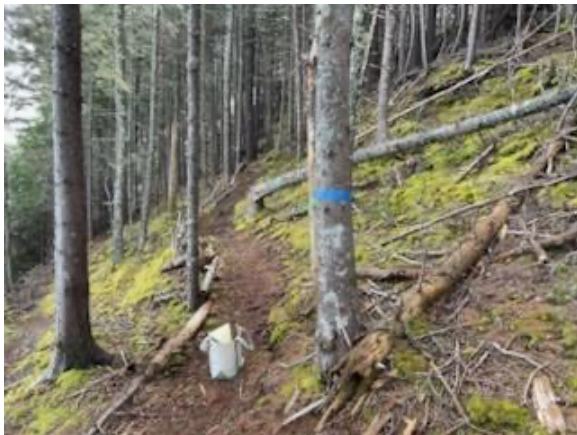
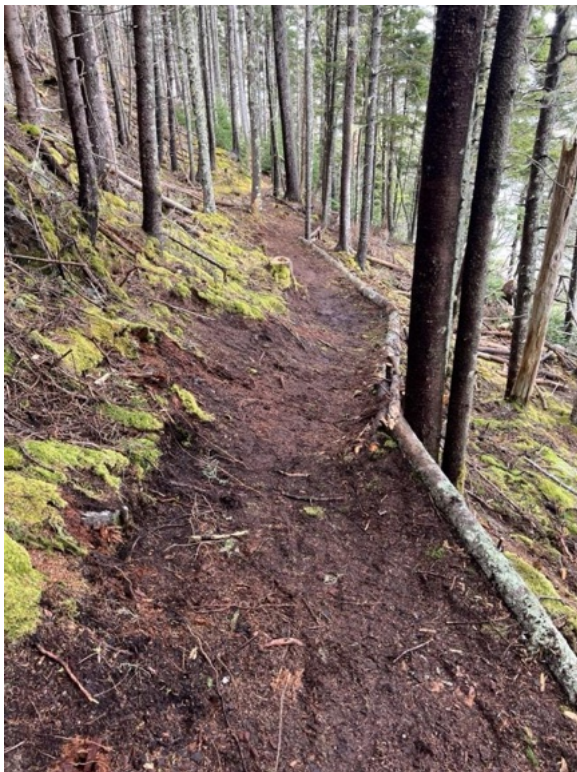
One rather dramatic outcome from the team's efforts was the clearing of the entrance to the Burying Point. Where two large trees had lain precariously across the trail, severely restricting access to the Burying Point Beach, there was not a clear path. Additionally, along the Burying Point Trail, a new segment that had replaced the original path was re-emphasized and reinforced using cut logs, rebar, and shaved wood spikes.

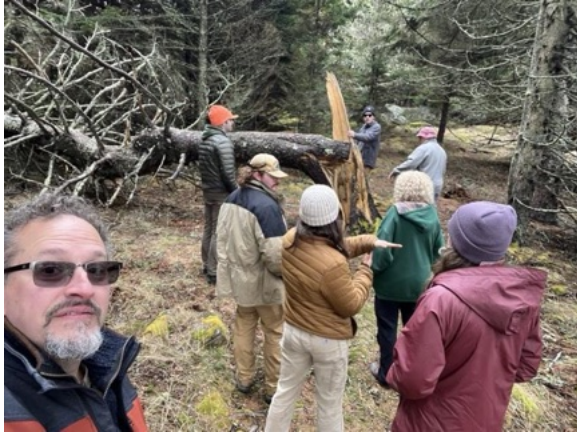
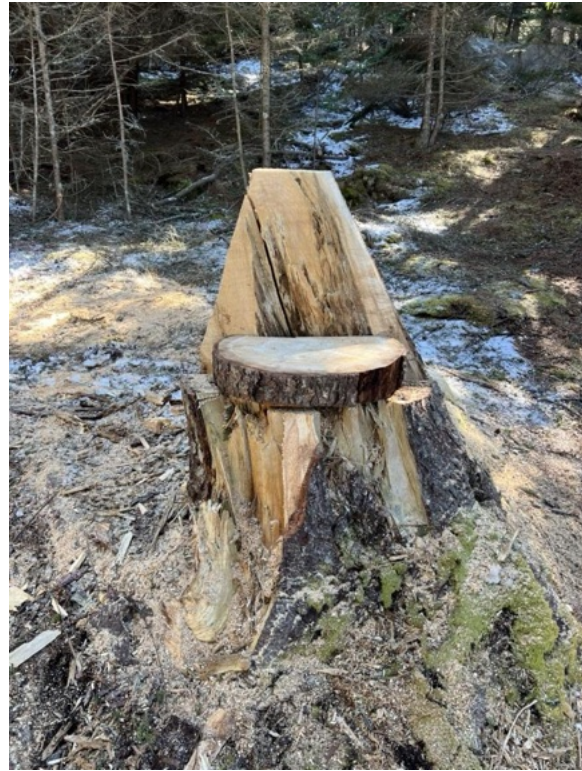
Those familiar with the Summit Path will recall the jagged tree-fall on that path. That particular fracture pattern is referred to by loggers as a “barber’s chair,” given the obvious physical resemblance. We now have a new Barber’s Chair in its place.

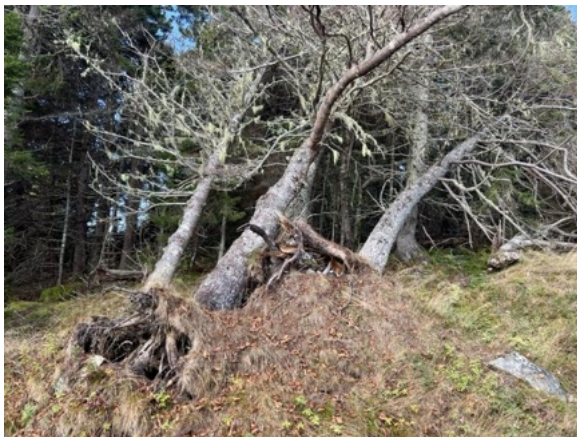
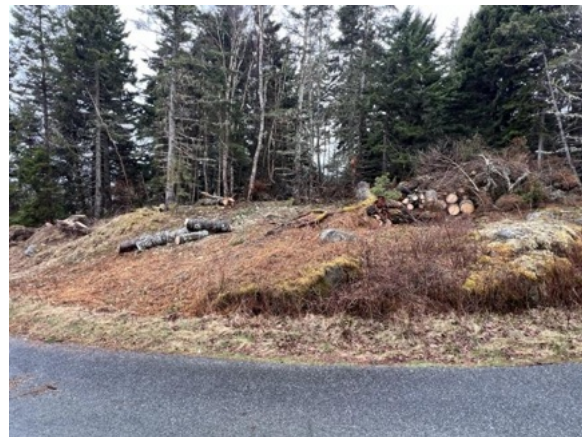
One particularly unattractive and highly visible sight to greet lighthouse visitors for the past year has been the five large blown-over spruces adjacent to the road near the approach to lighthouse. A sub-team of the MCC group was dispatched to work on these, and with the assistance of Charlie Weigle and his skid-steer, they managed to convert all five into several habitat piles, giving the area a much cleaner look.

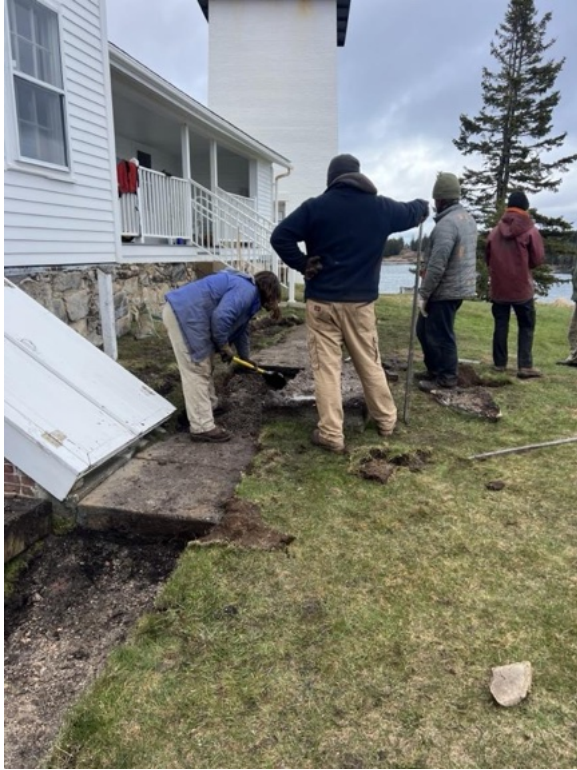
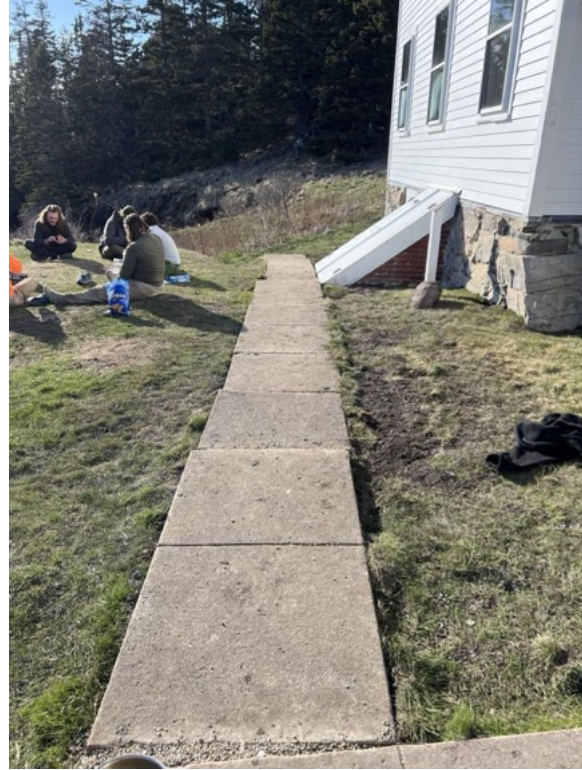
Two projects were finished in the immediate vicinity of the Keeper's House: the concrete-block walkway in back of the Keeper's House was re-leveled, and the walkway in the front of the Keeper's House had river rock added over the top of the path, matching it to the rest of the front walkway.

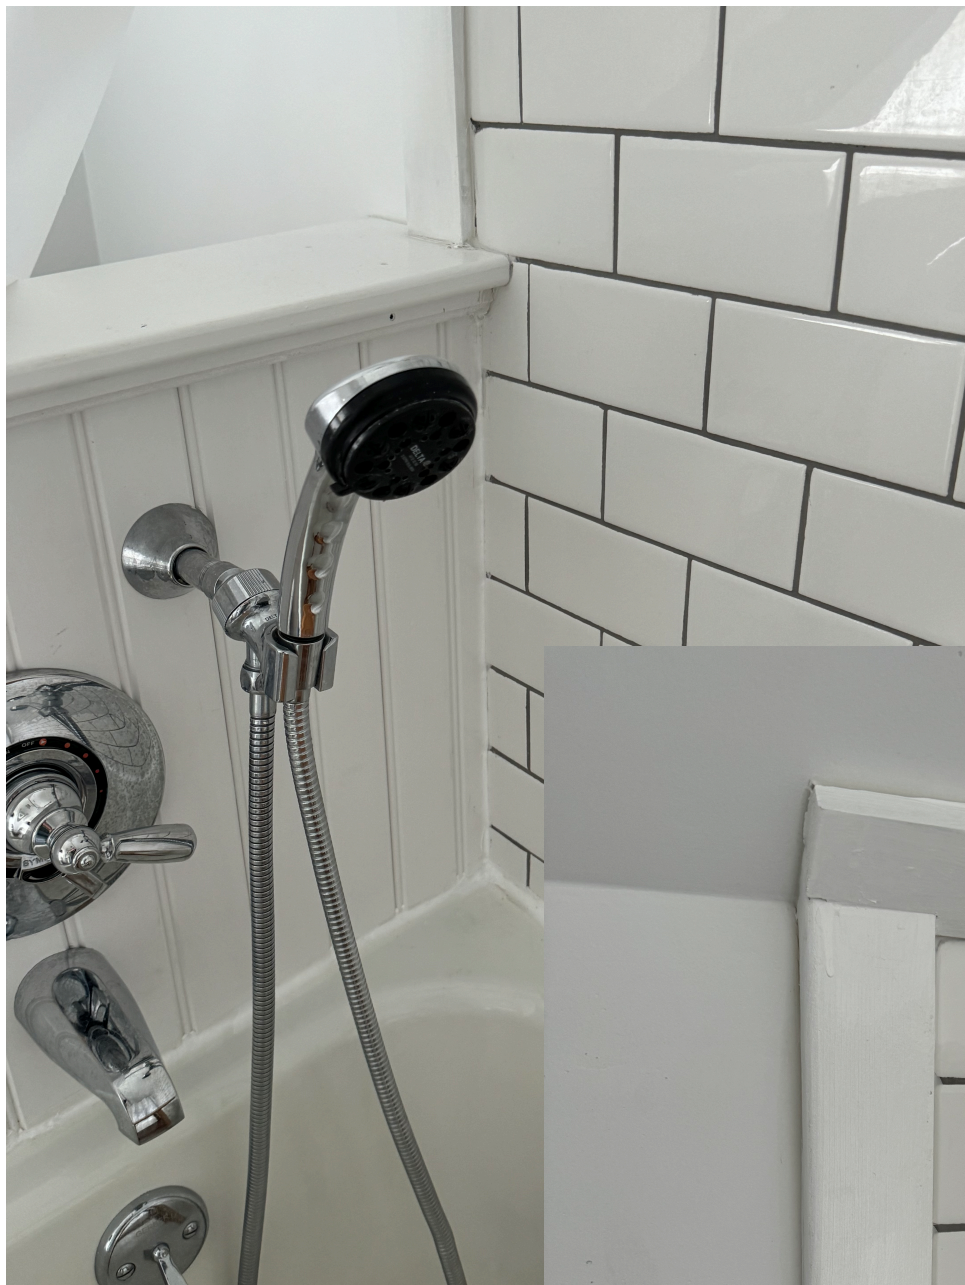
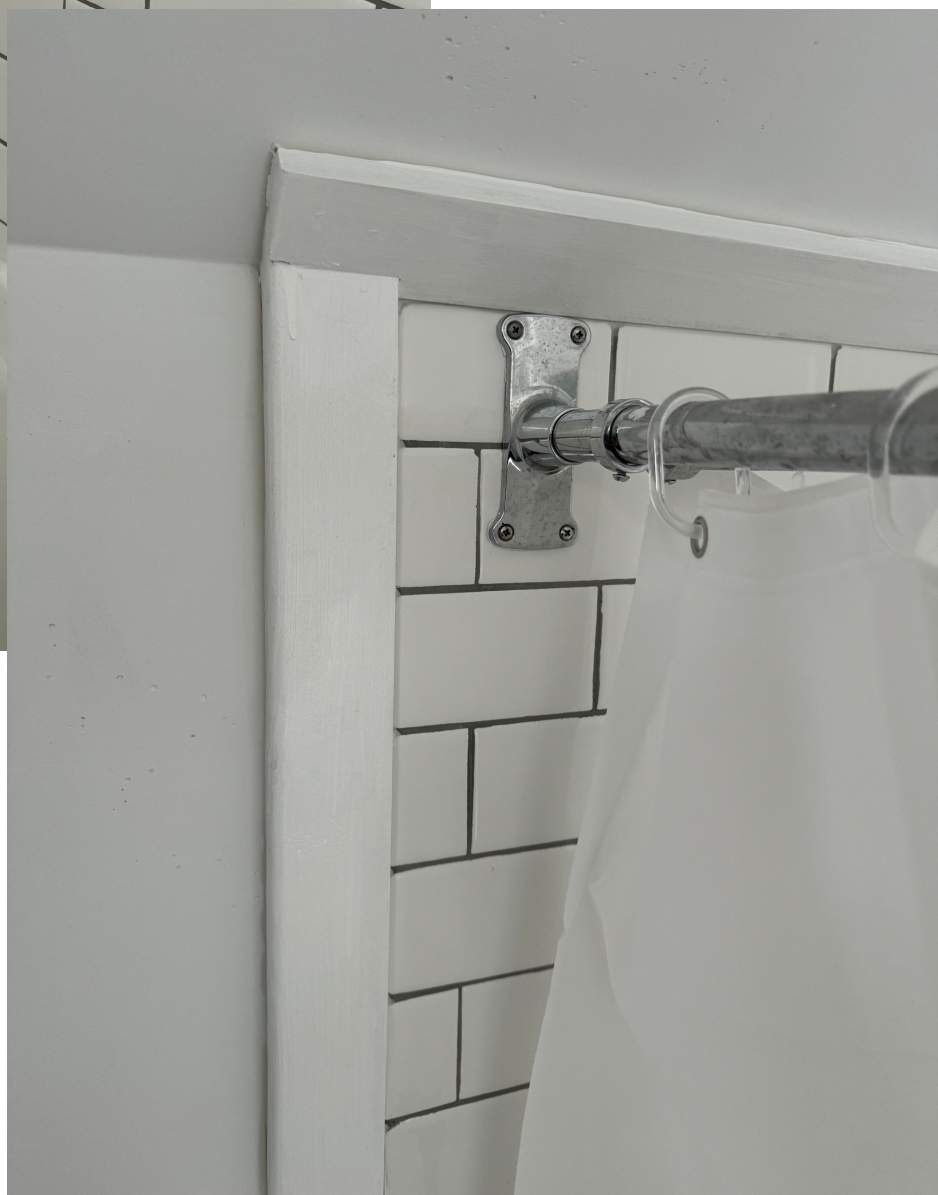
ITEM 7

Keeper's House BathTub Surround
using Subway Tiles

The bathtub backsplash tiling completed by the Resident Volunteer last year is holding up well (*Item 7*).
